**MICHIGAN DEPARTMENT OF ENVIRONMENTAL QUALITY
LAND AND WATER MANAGEMENT DIVISION
DAM INSPECTION REPORT**

DAM NAME		DAM ID	COUNTY
Duck Lake Dam		1952	Grand Traverse
DATE OF INSPECTION	NAME OF WATERBODY	SECTION, TOWN, RANGE	LEVEL THIS DATE
December 4, 2012	Duck Lake	Sec. <u>22</u> T <u>26N</u> R <u>12W</u>	
DATE ELEVATION SET BY COURT	LEGAL LEVEL	DRAWDOWN LEVEL	HIGH WATER MARK ELEVATION
June 18, 1959	837.3	835.00

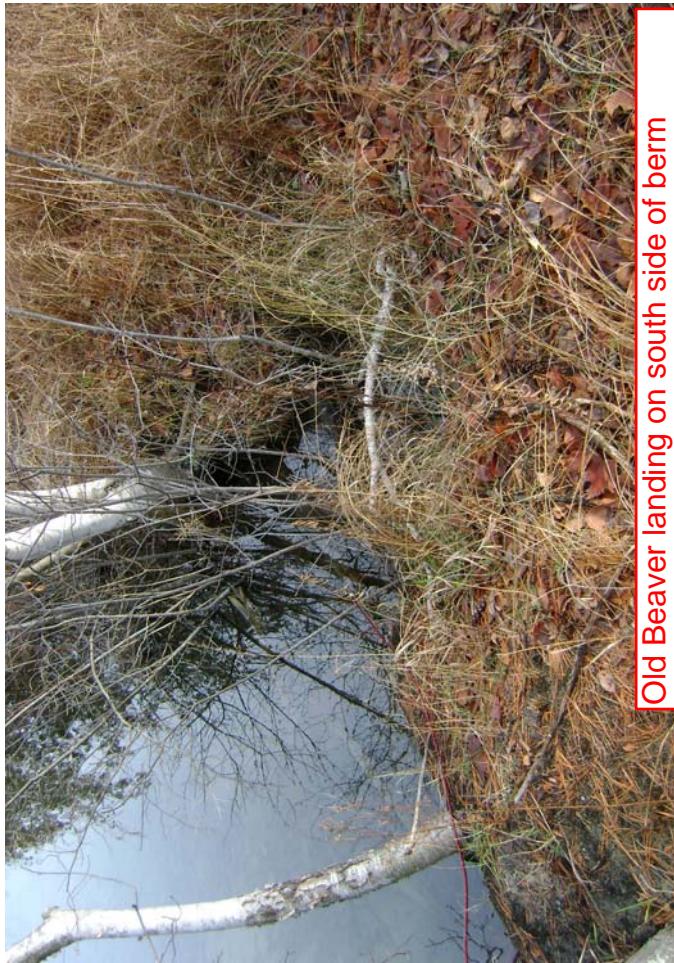
Old Beaver landing on south side of berm

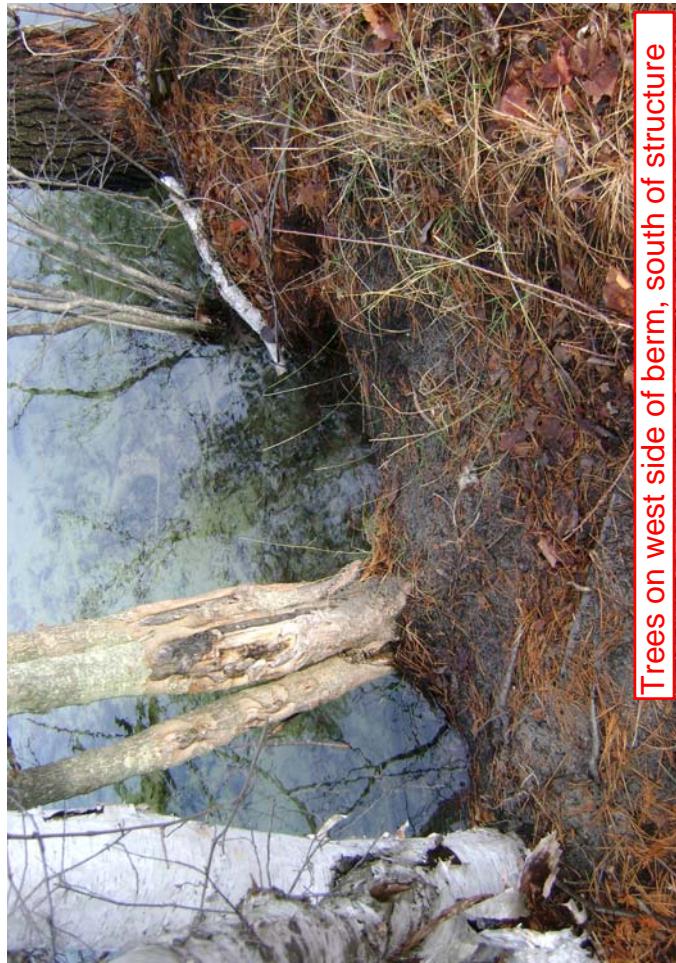
Trees on west side of berm, south of structure

Tree Removal

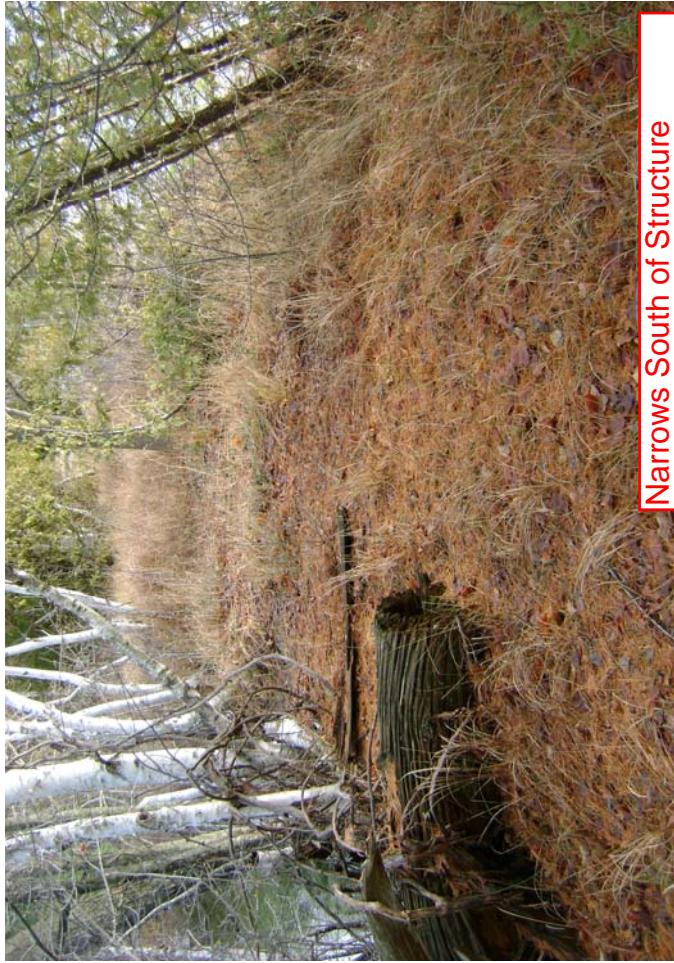
Narrows South of Structure
