June 2015 Dam Inspection Report

DUCK LAKE LEVEL CONTROL STRUCTURE PART 307 INSPECTION

Dam Identification No.: 1952

Green Lake Township, Grand Traverse County, Michigan

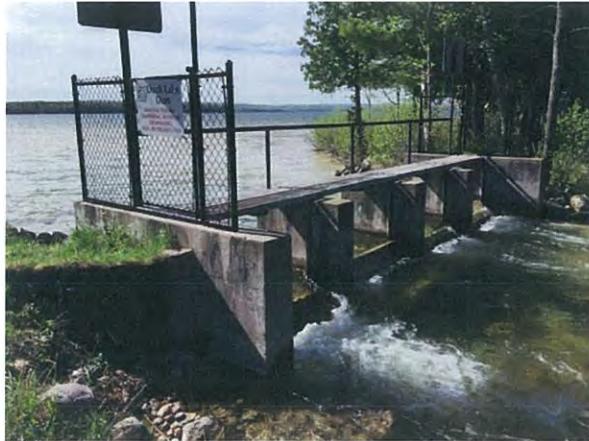
Name: IMG_2380

Description: Downstream of Dam looking upstream into Duck Lake. Note: The narrows are located on the west side of the Dam and extend approximately 300 feet southwest.

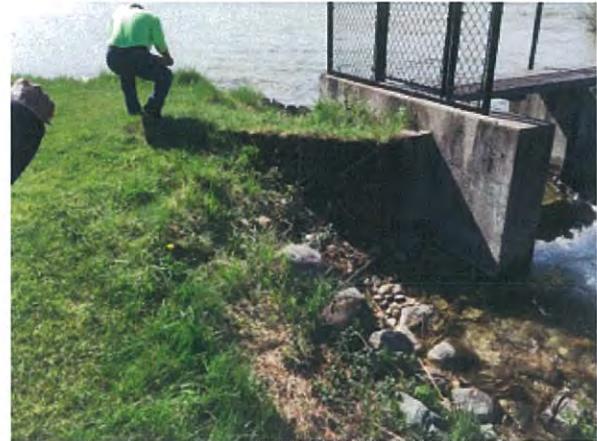
Name: IMG_2381

Description: Retaining wall on east side of Dam.

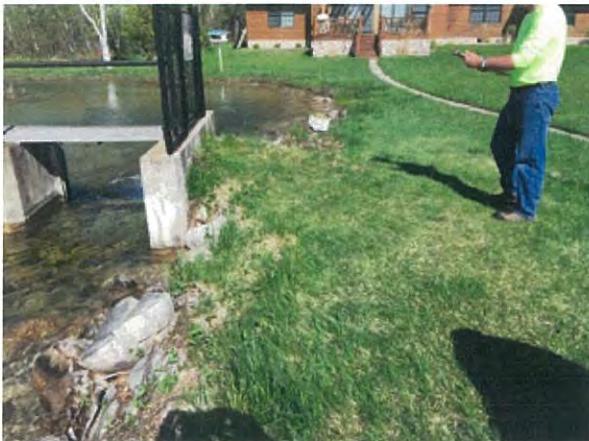
Name: IMG_2382

Description: Retaining wall on east side of Dam looking downstream.

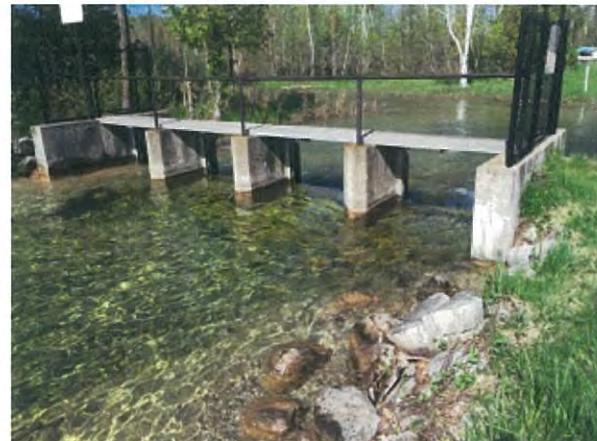
Name: IMG_2383

Description: Dam looking downstream.

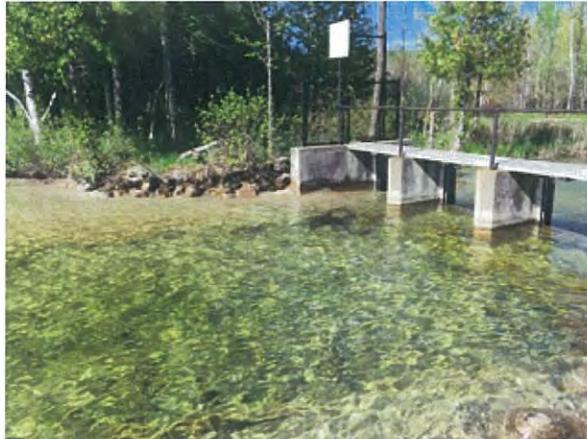
Name: IMG_2384

Description: Duck Lake Dam looking downstream pointing west. Note: Narrows located on west side of Dam and extend approximately 300 ft southwest.

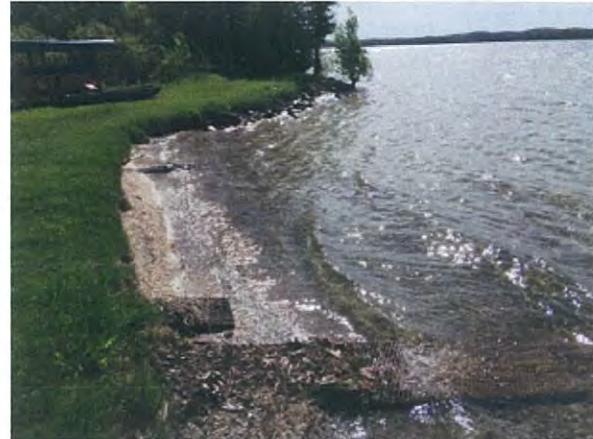
Name: IMG_2385

Description: Shoreline immediately east of Duck Lake Dam.

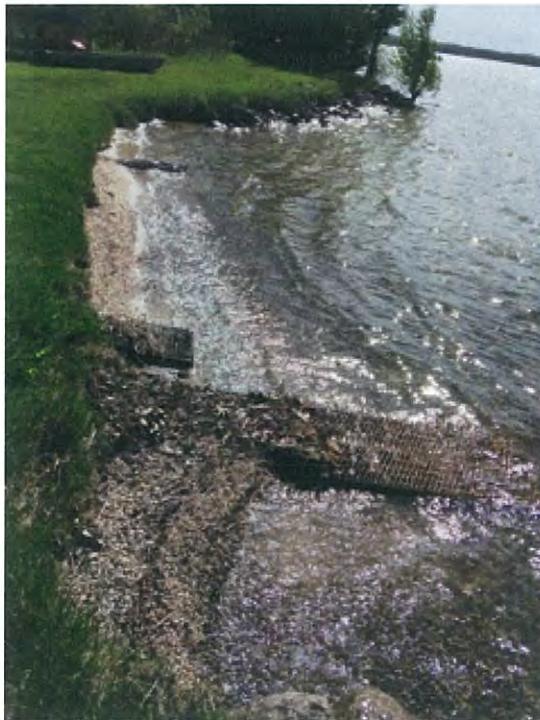
Name: IMG_2386

Description: Shoreline immediately east of Duck Lake Dam.

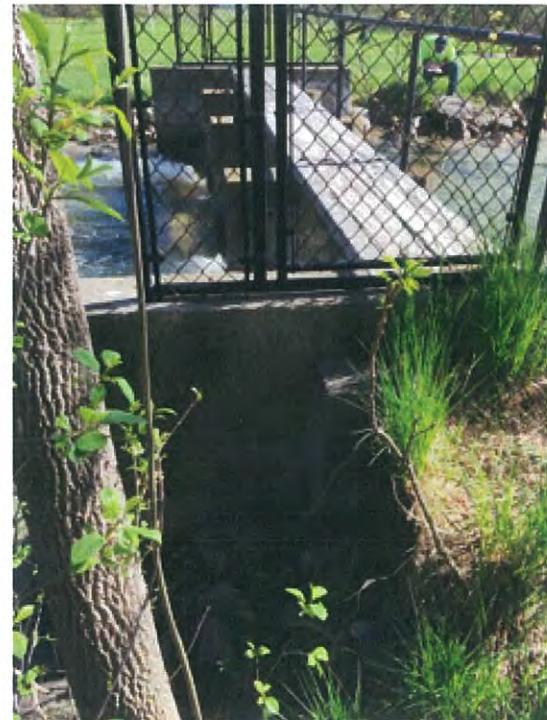
Name: IMG_2387

Description: West side of Duck Lake Dam.

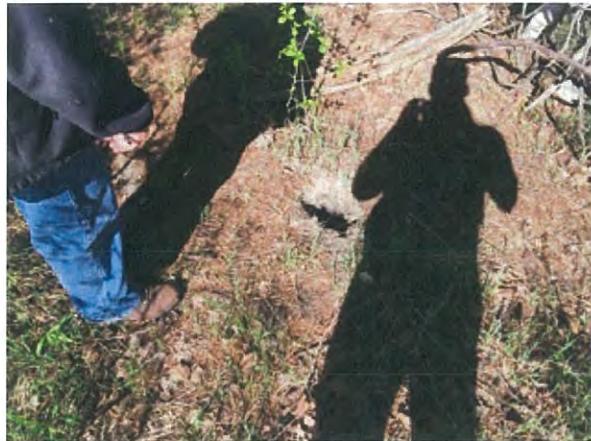
Name: IMG_2388

UPSTREAM	CROWN	DOWNSTREAM
VEGETATIVE COVER	Grass and small brush	Grass, Small brush and trees	
EROSION	None	None	Scour hole on right abutment
SEEPAGE			None
SLIDES, SLUMPS & CRACKS	None	None	None
ANIMAL BURROWS	None	One - small	None
WAVE ACTION PROTECTION	Rip-rap		Rip-rap
REMARKS*	The earth embankment is not a functional part of the dam. The original grade is higher than the water surface at both abutments	The outlet stream flows to within 18 feet of the edge of the lake and there are animal trails present at the narrow portions. (see map) No erosion present

Description: Walking along earthen Dam and found a rodent burrow.

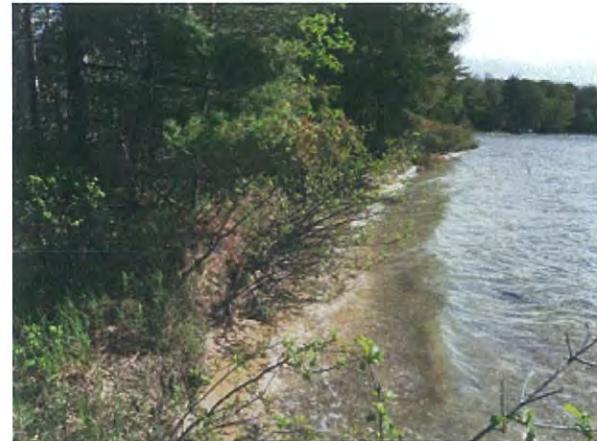
Name: IMG_2389

Description: Shoreline of earthen Dam looking east.

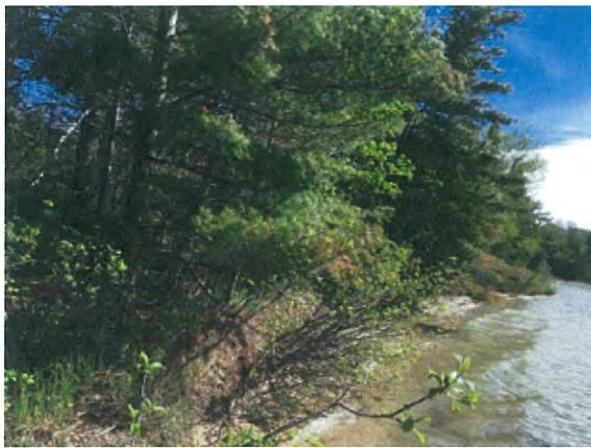
Name: IMG_2390

Description: Shoreline of earthen Dam looking east.

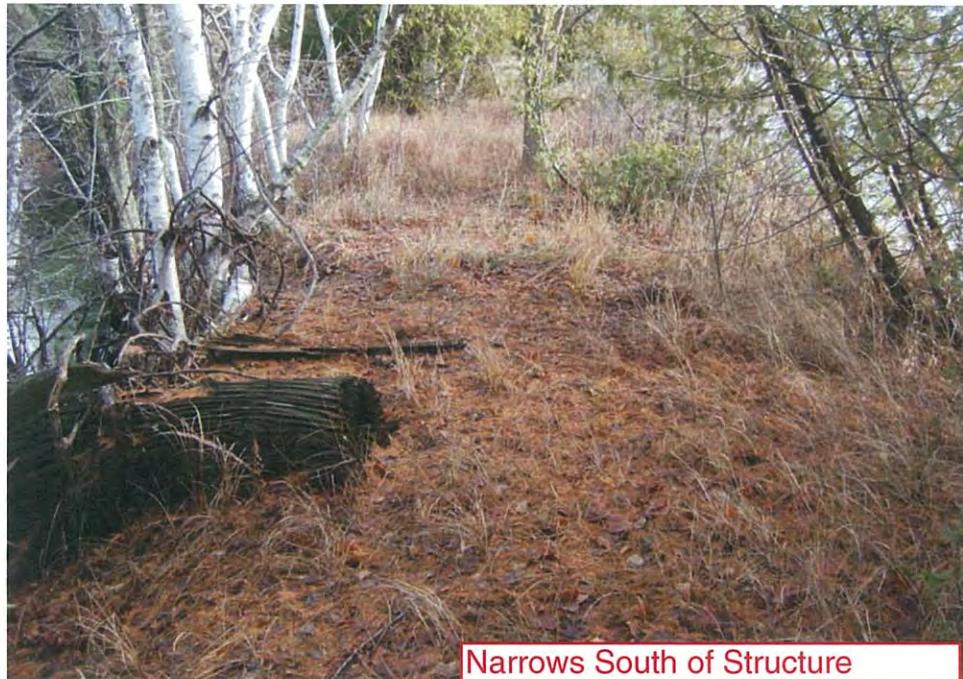
Narrows South of Structure

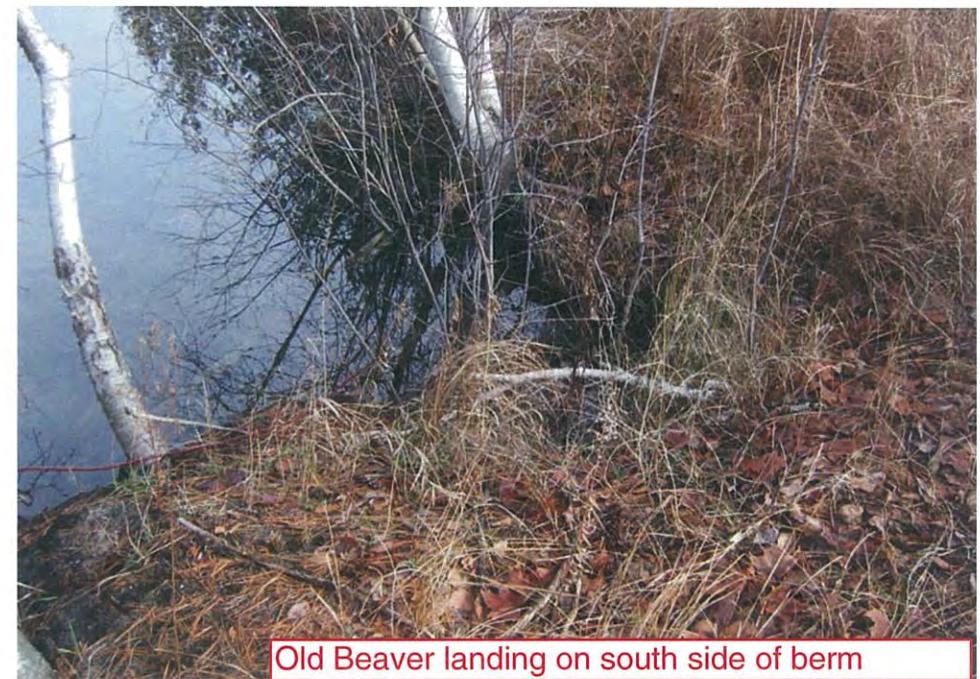
Old Beaver landing on south side of berm

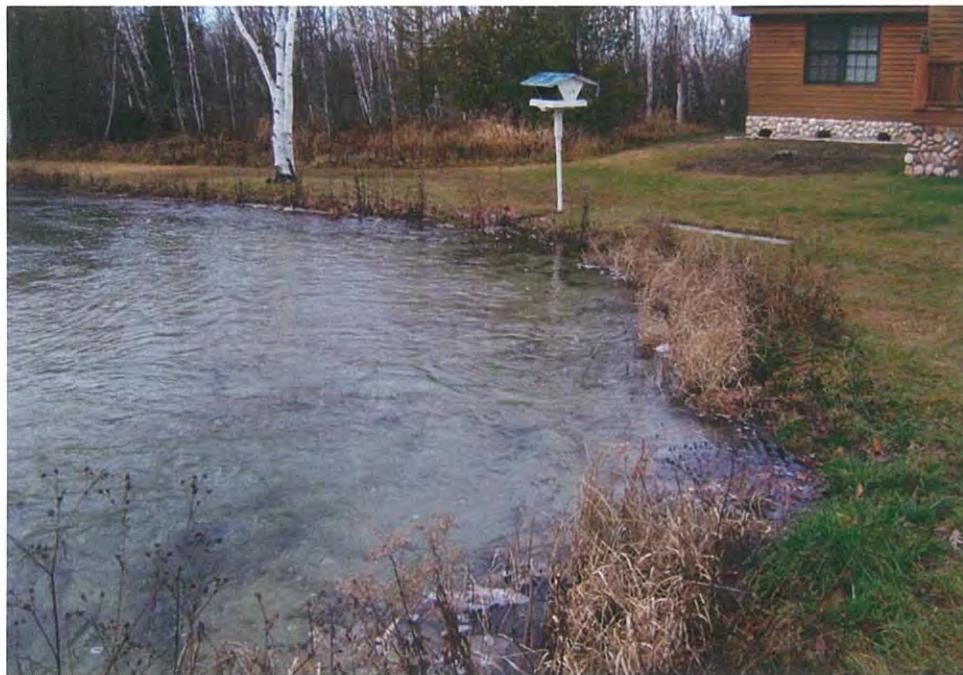
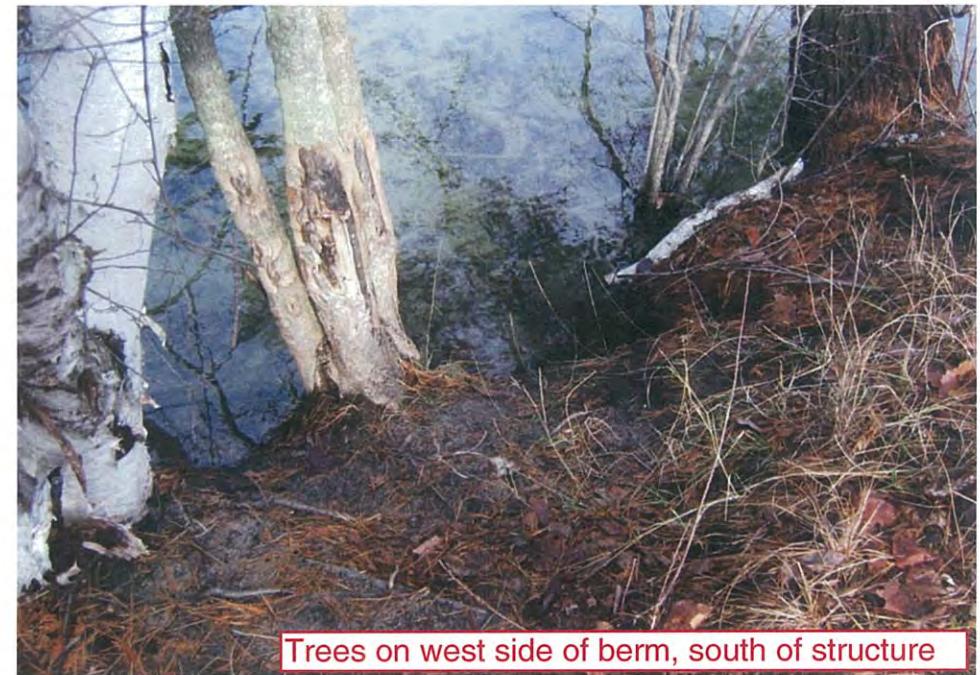
Trees on west side of berm, south of structure

Tree Removal
