FINAL REPORT

GRAND TRAVERSE COUNTY PHYTOREMEDIATION PROJECT

Grand Traverse County, Michigan

December 20, 2018

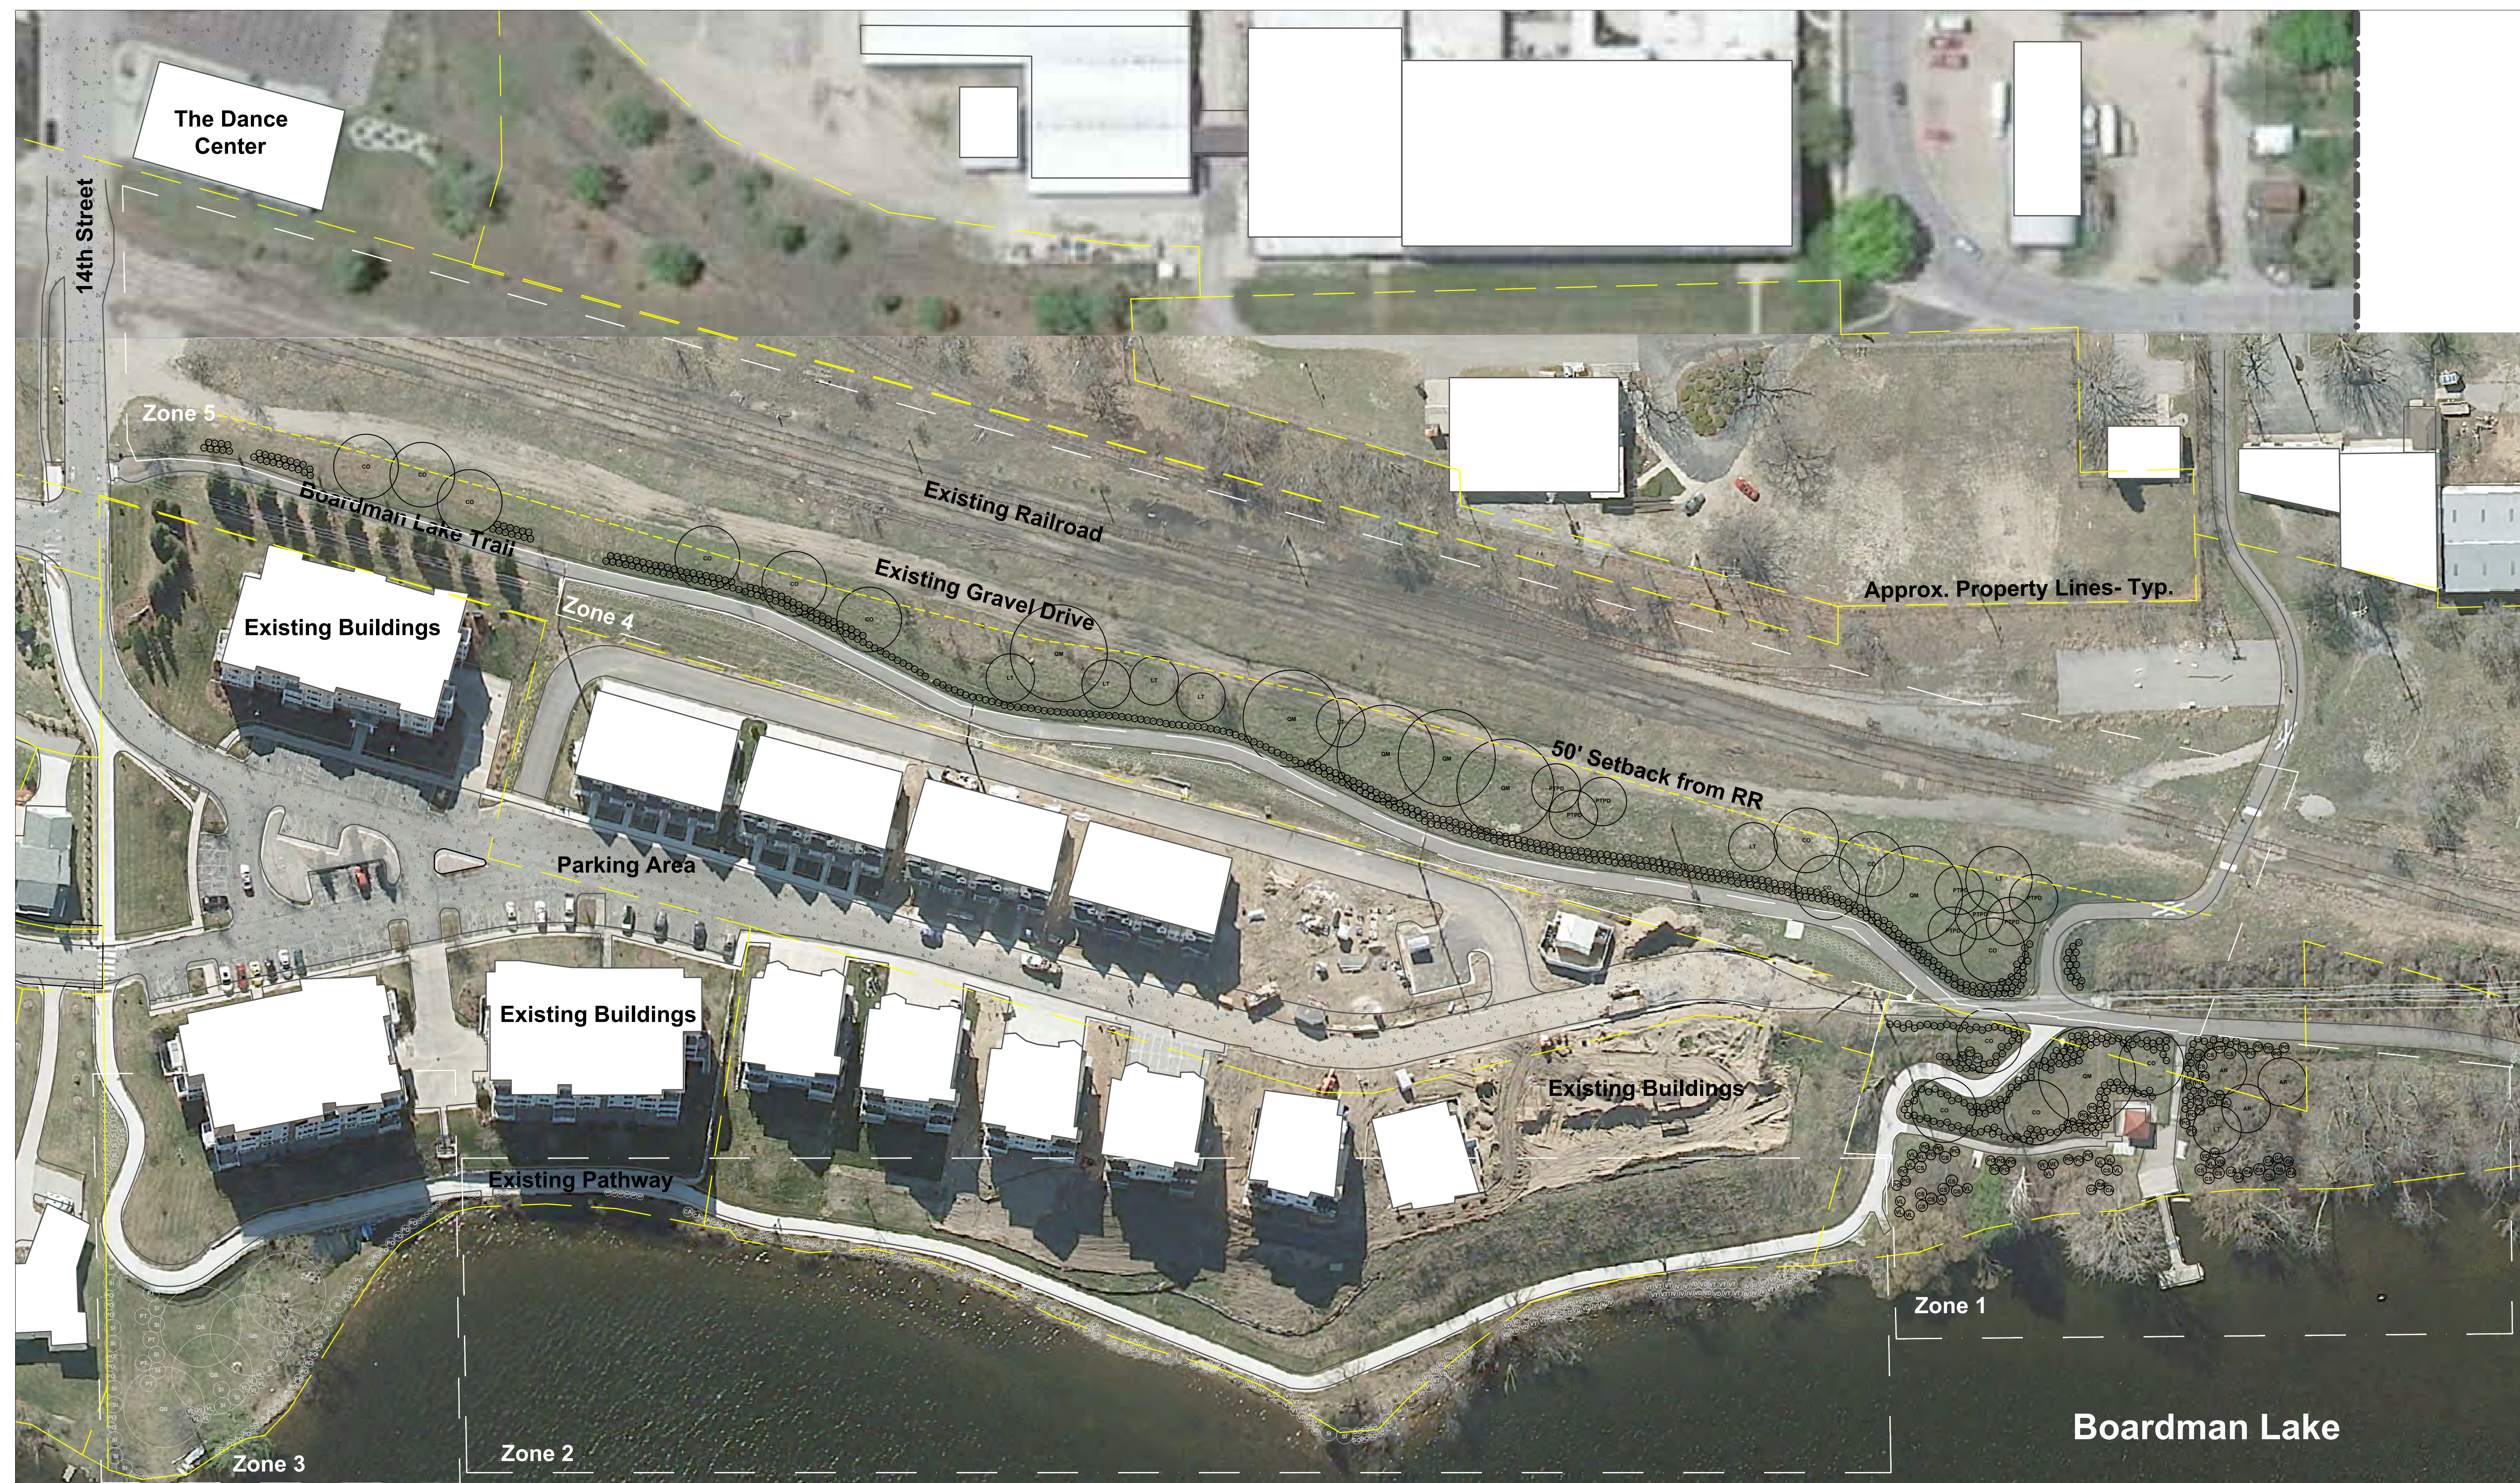
Figure 2A
Boardman Lake Planting Areas

Site Planting Plan
Scale: 1" = 50'

The Boardman Lake Site consisted of 5 planting zones (see **Figures 2A through E**). Plantings were completed in Zones 1-4 in 2017 while the Zone 5 plantings were completed by the contractor in collaboration with the railway property owner and MDOT in June 2018. As shown in **Figures 2A through C**, Zone 5 plantings were integrated with previous plantings along the north side of the property and adjacent to the existing railroad and recreational trail. A total of 1,310 plantings (see **Figure 2E**) were completed on the Boardman Lake Site. **Figure 2E** also identifies names and quantities of trees and shrubs in Zones 1-4, all of which are native to Michigan. See below for a summary of all Boardman Lake plantings.

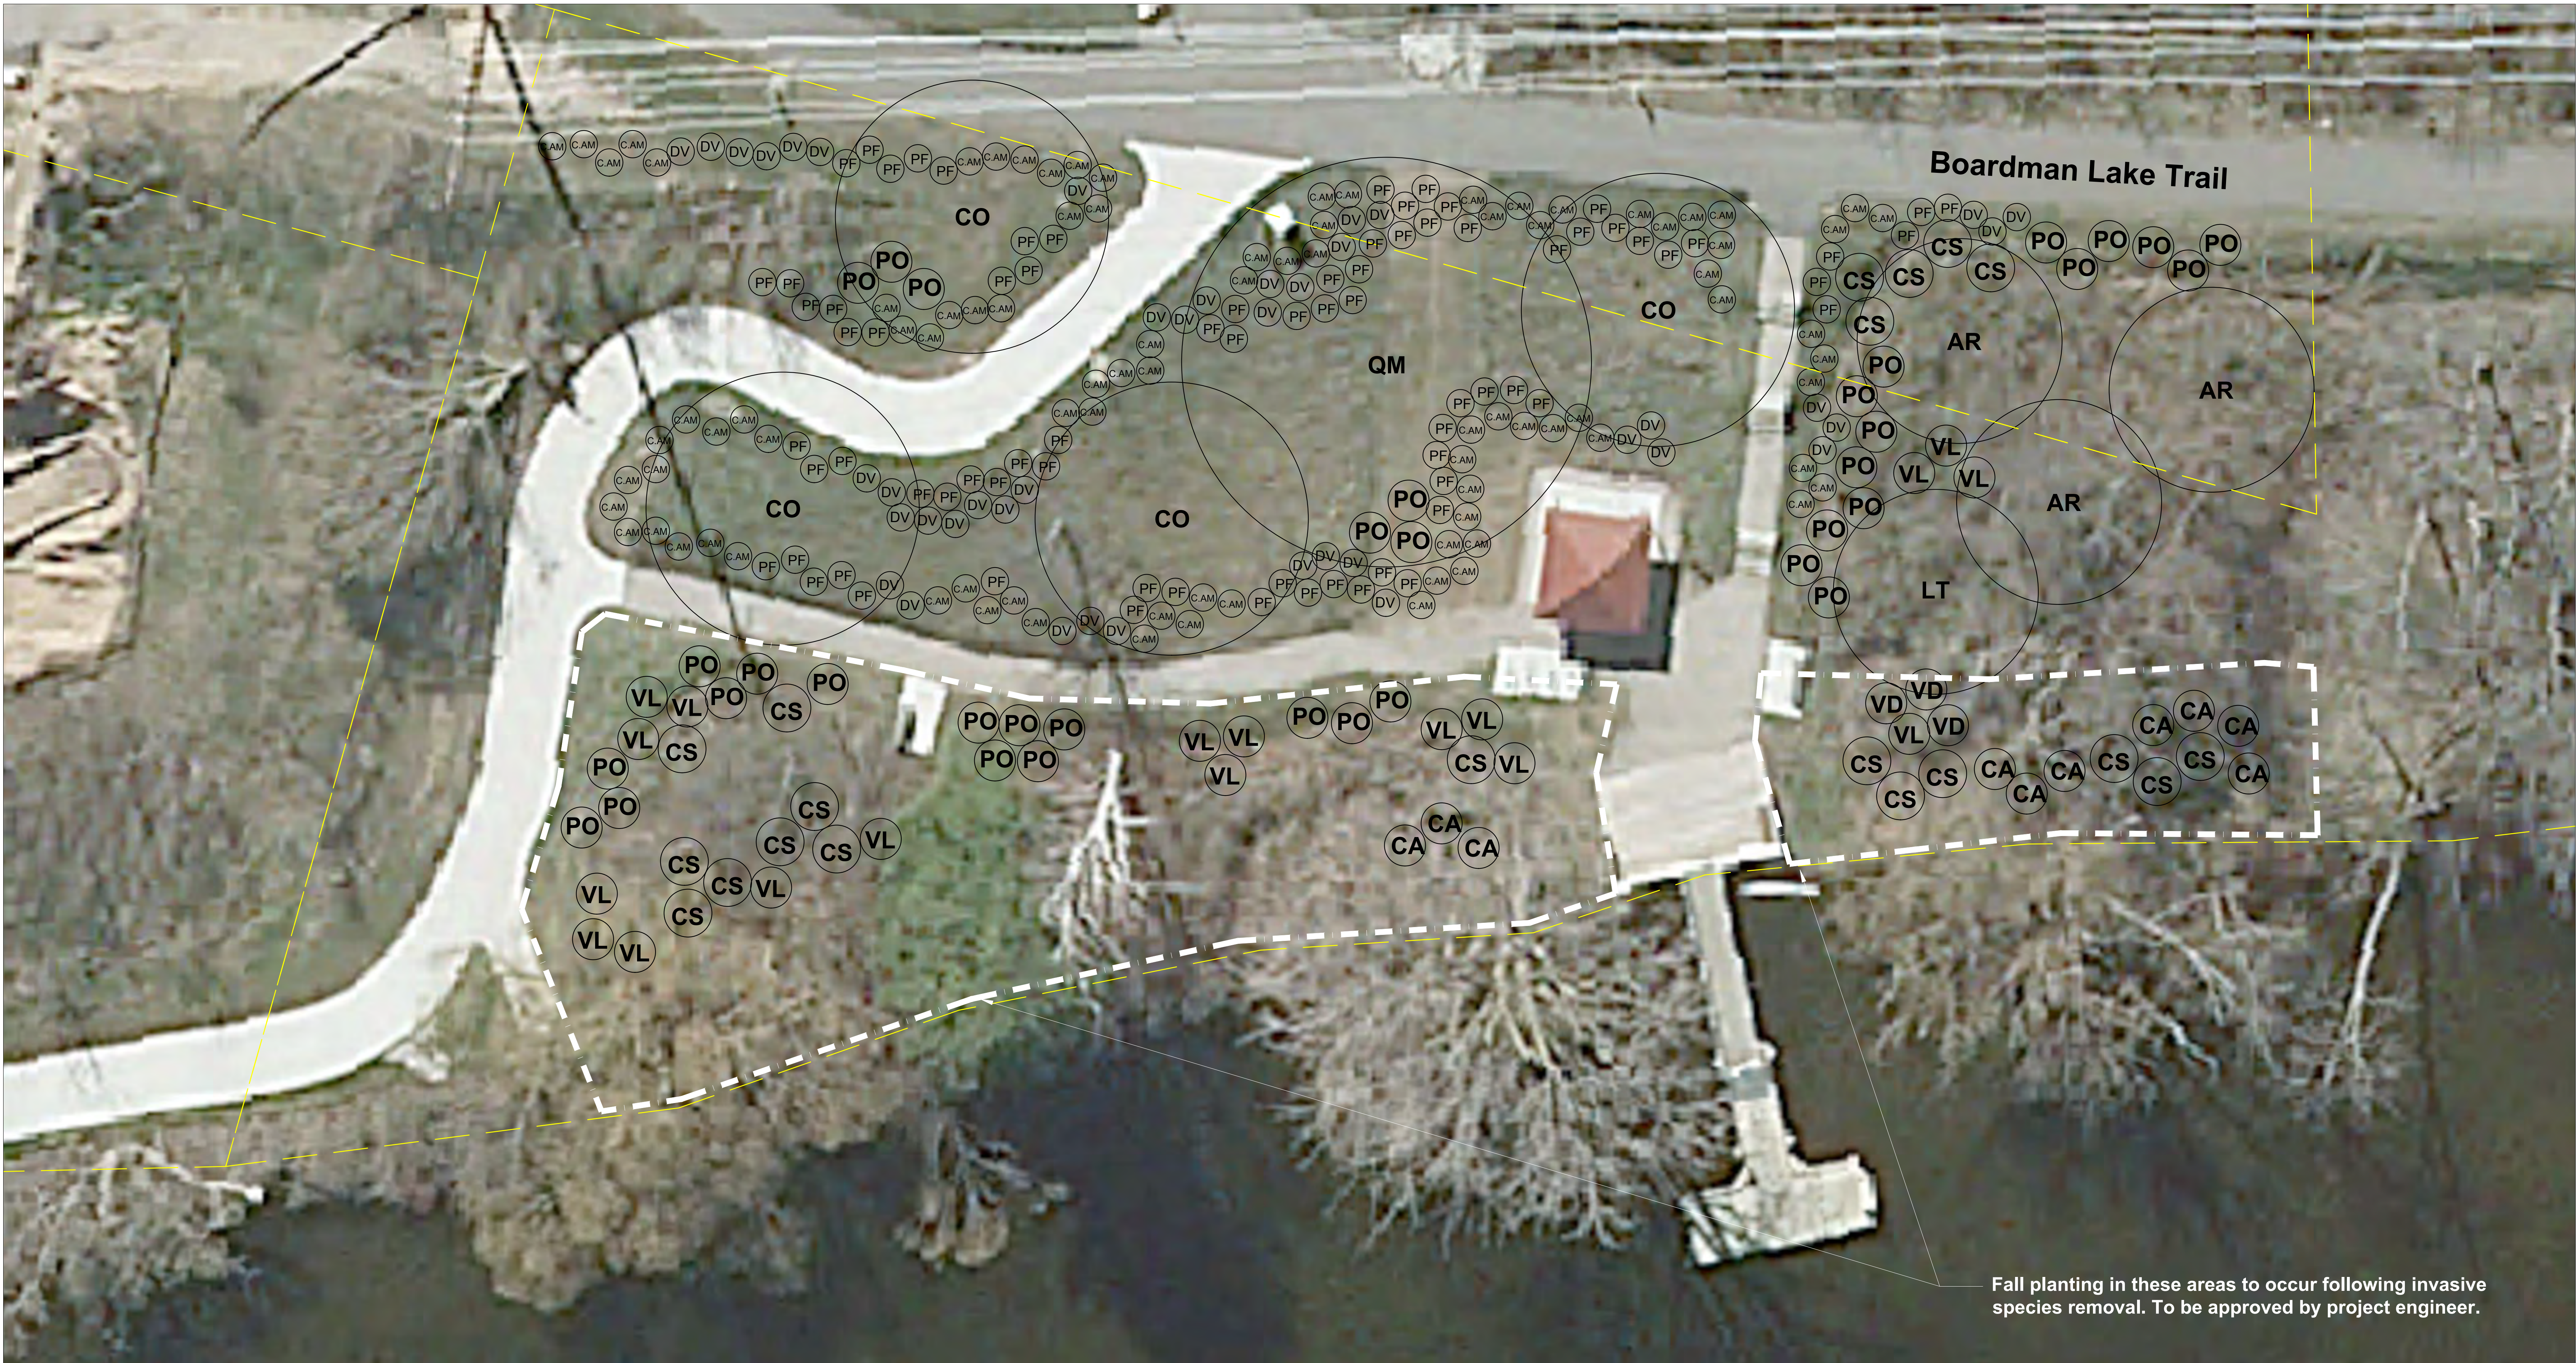
Figure 2D
Boardman Lake Planting Areas

1 Zone 1 - Planting Plan
4 Scale: 1" = 10'

ZONE 1
PLANTING
PLAN
DETAIL

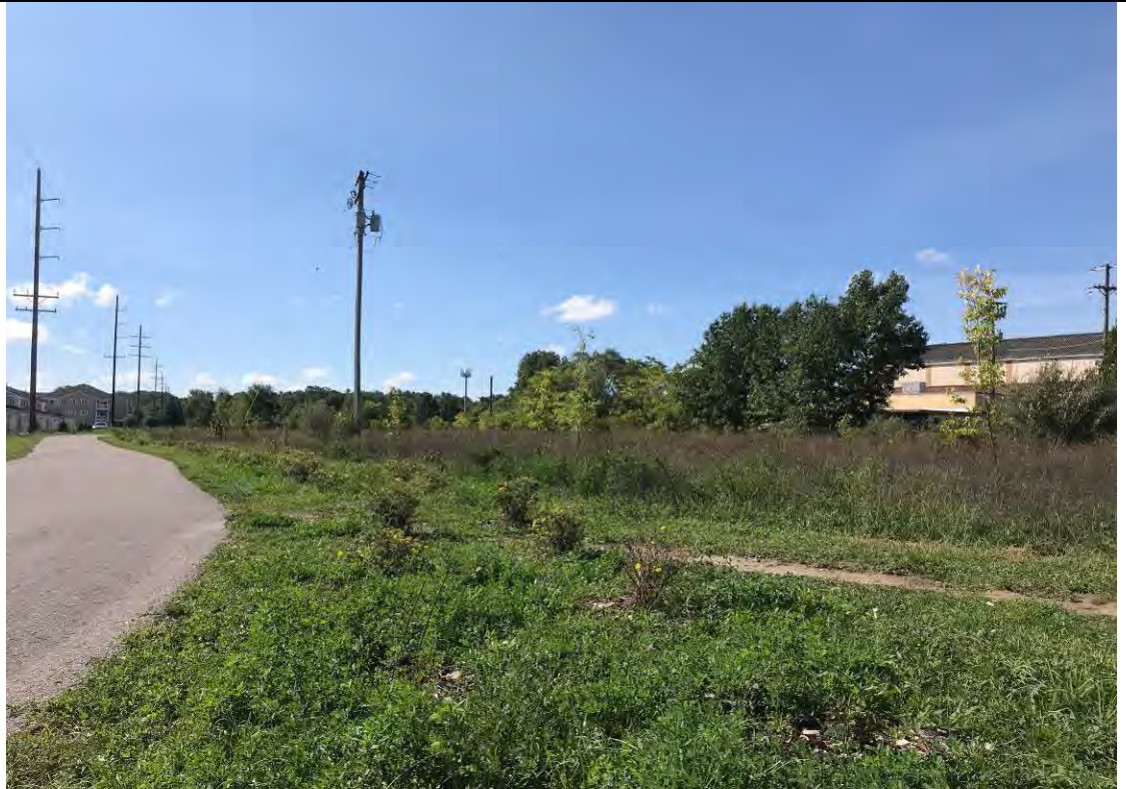
Photo No.**13****Date:**

Zone 5 Plantings

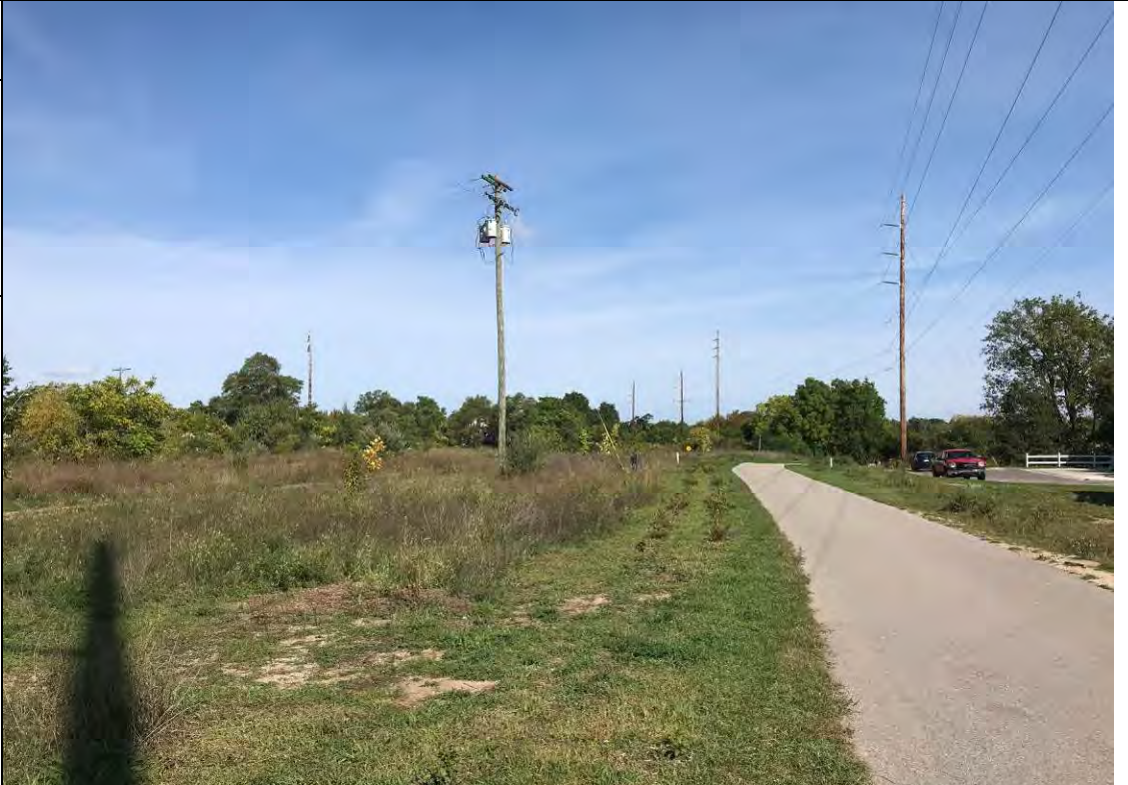
**Photo No.****14****Date:**

Zones 4 and 5 Plantings

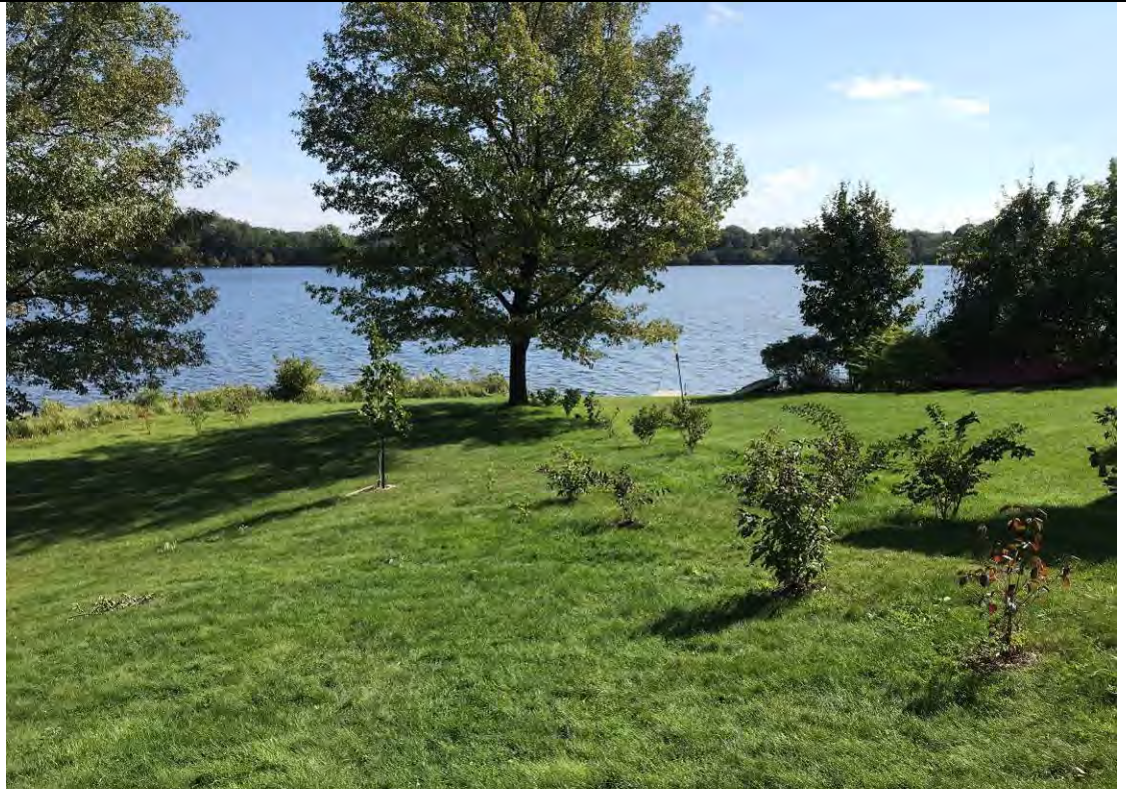
Photo No.**17****Date:**

Zone 3 Plantings

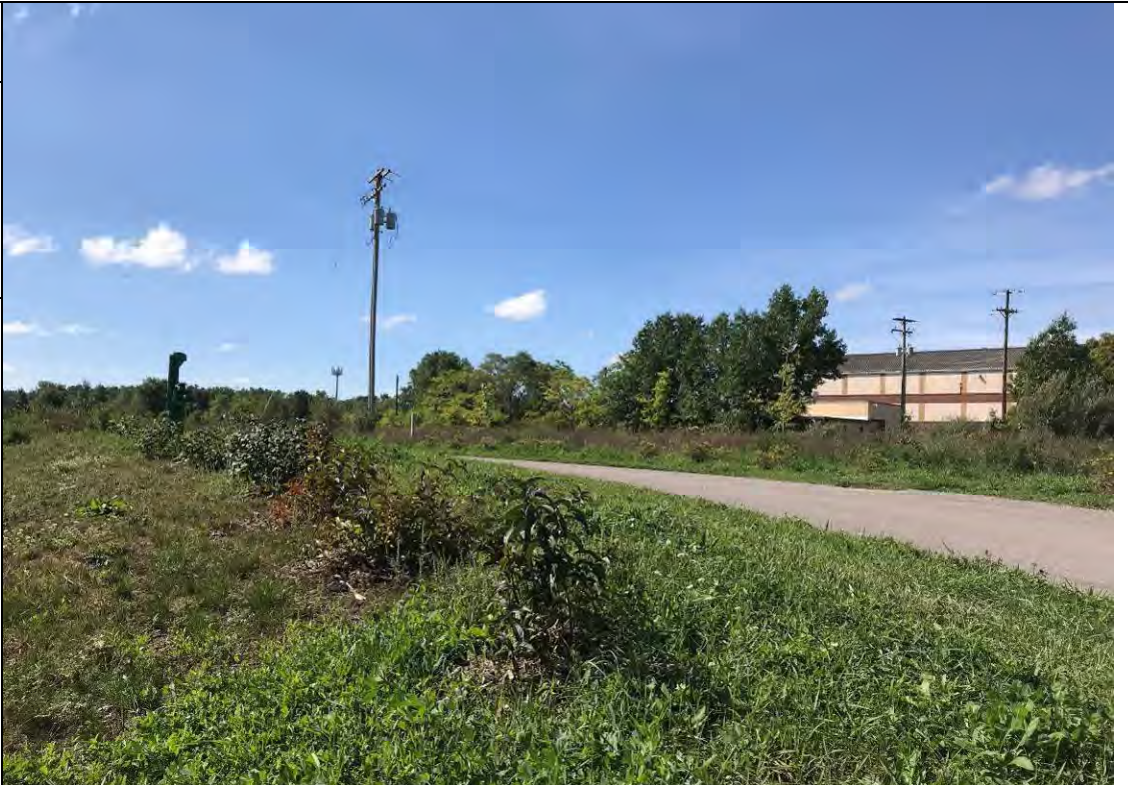
**Photo No.****18****Date:**

Zone 4 and 5 Plantings

Cone Drive Textron in
Background

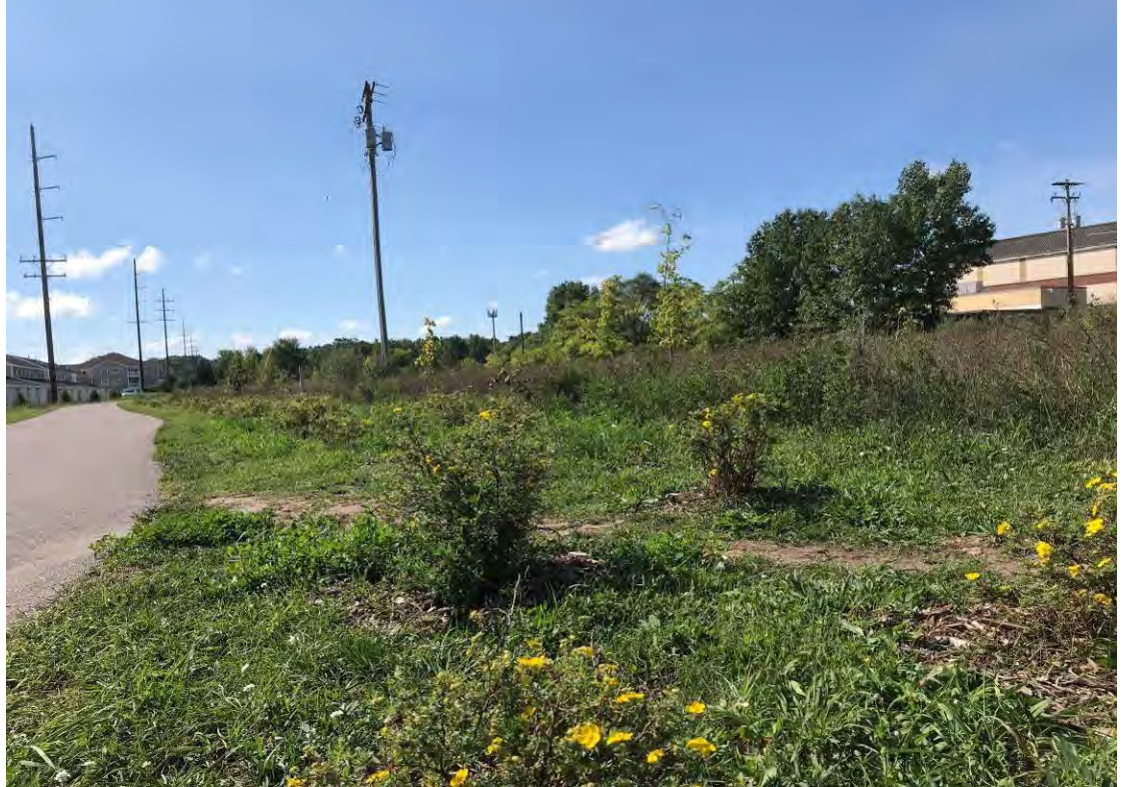
Photo No.**19****Date:**

Zones 4 and 5 Plantings

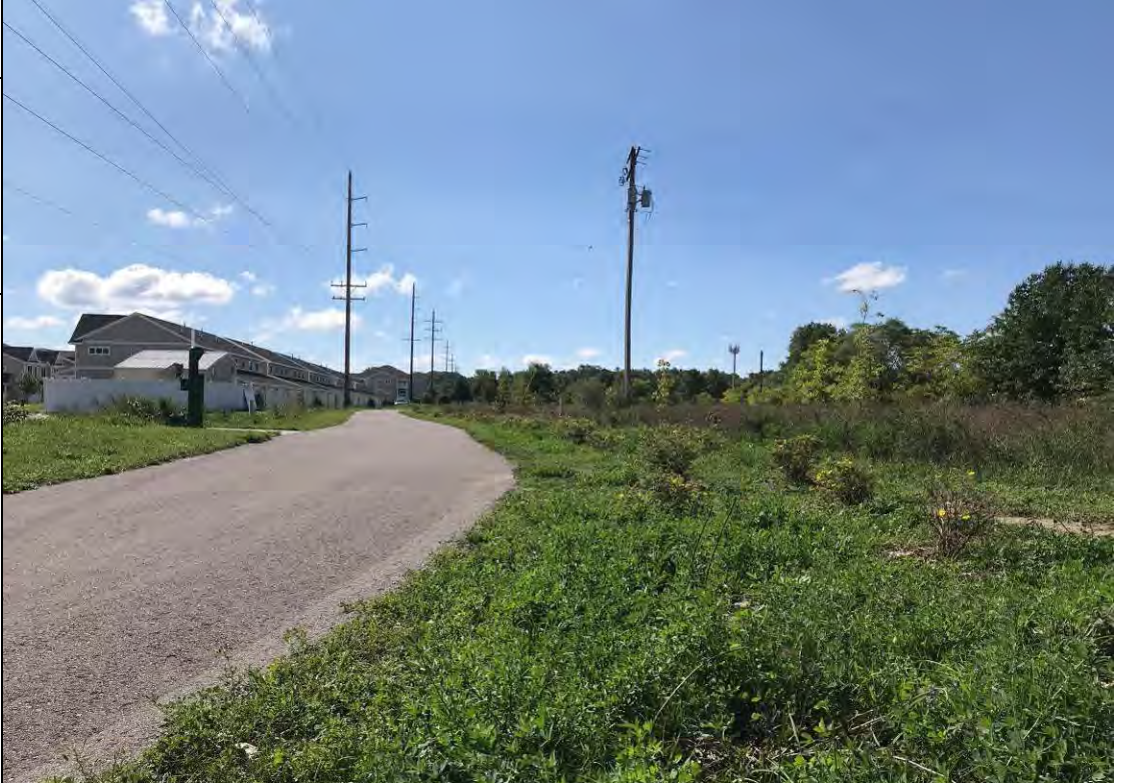
**Photo No.****20****Date:**

Zones 4 and 5 Plantings

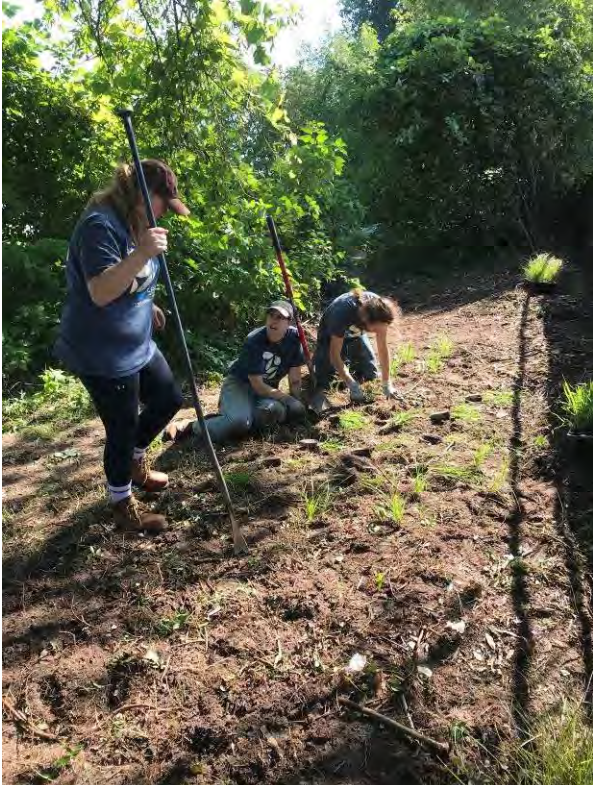
Direction Photo Taken: East			
Description: Planting Beach Grasses and Trees

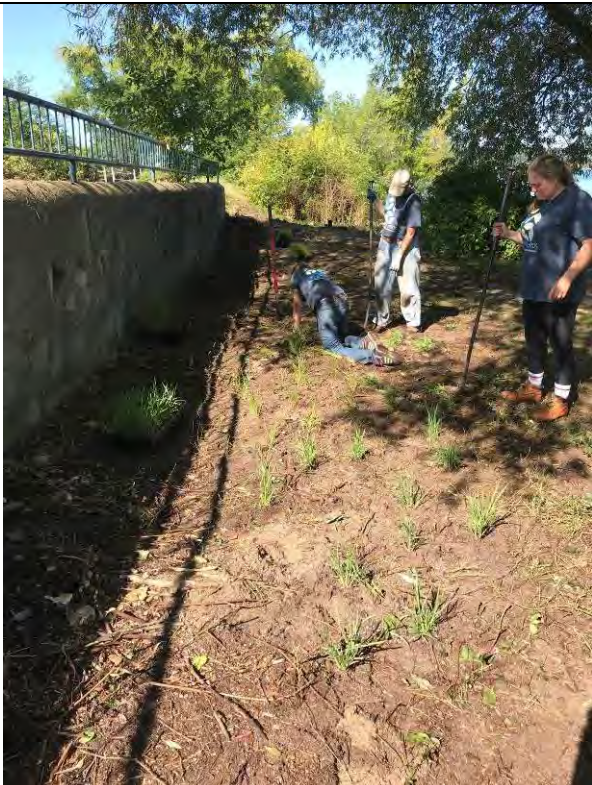
Direction Photo Taken: West			
Description: Planted Beach Grasses

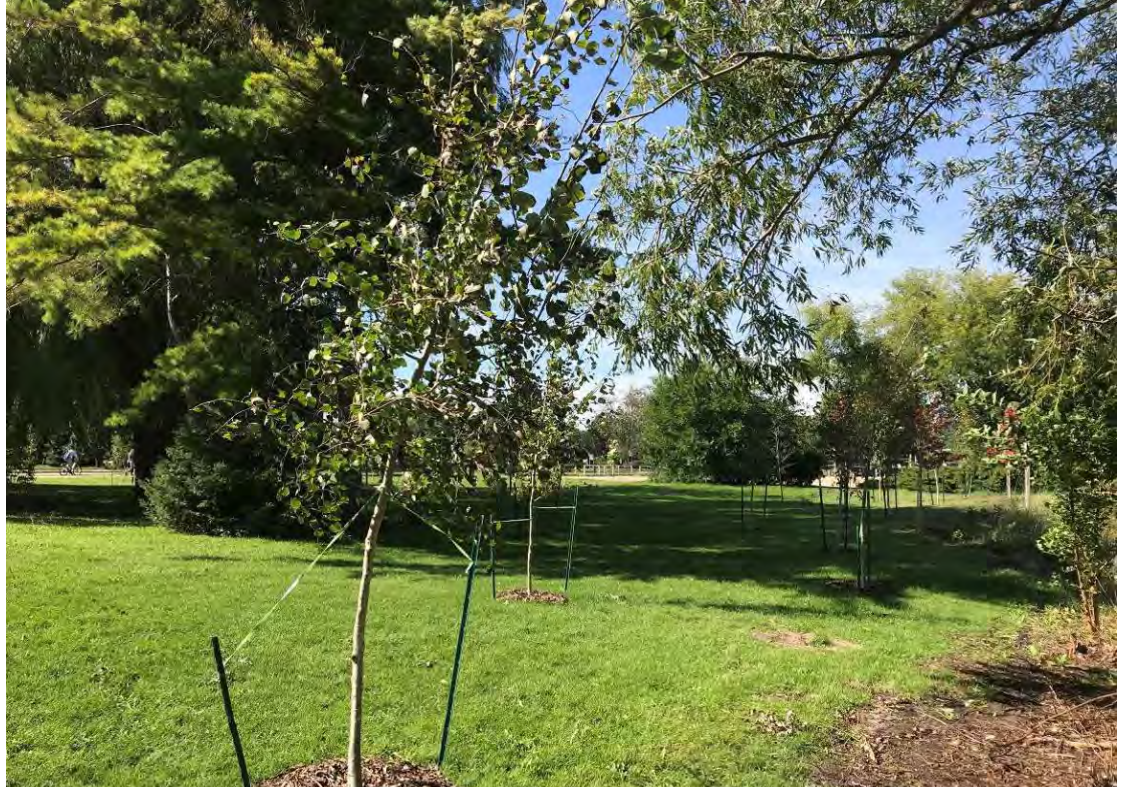
Photo No.**17****Date:**

Quaking Aspen

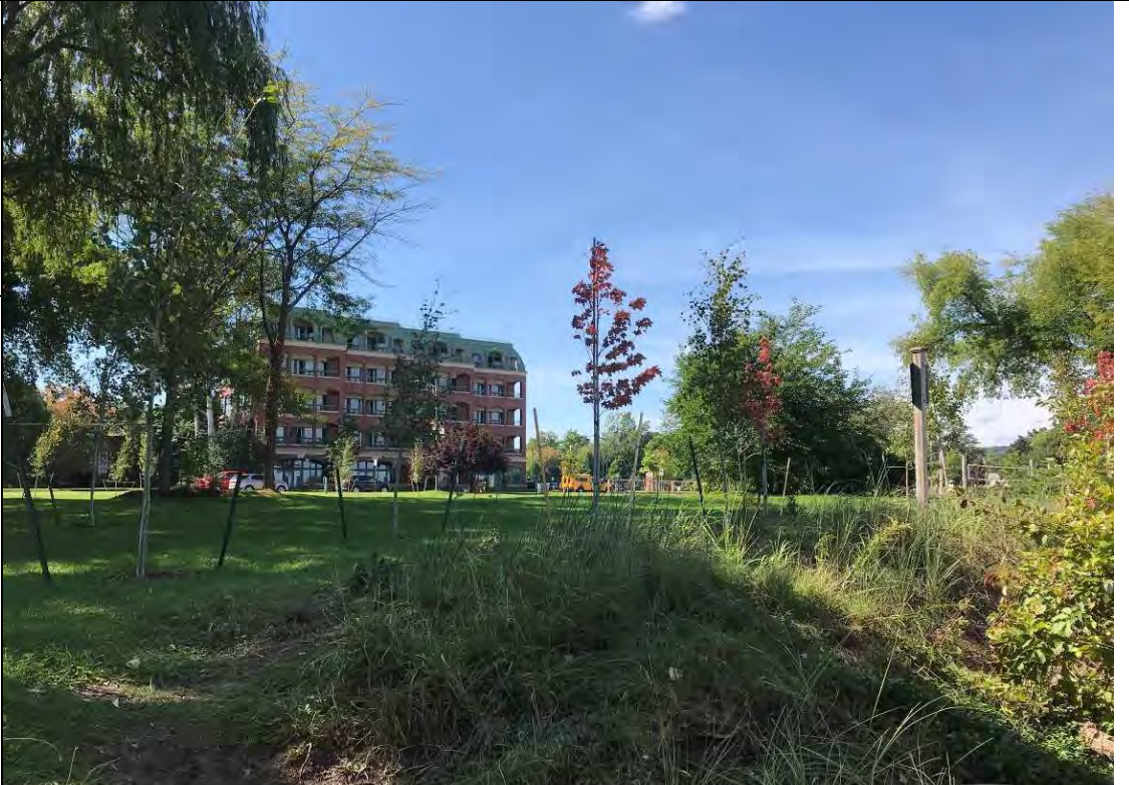
**Photo No.****18****Date:**

Grasses and Trees Blended with Existing Trees and Shrubs

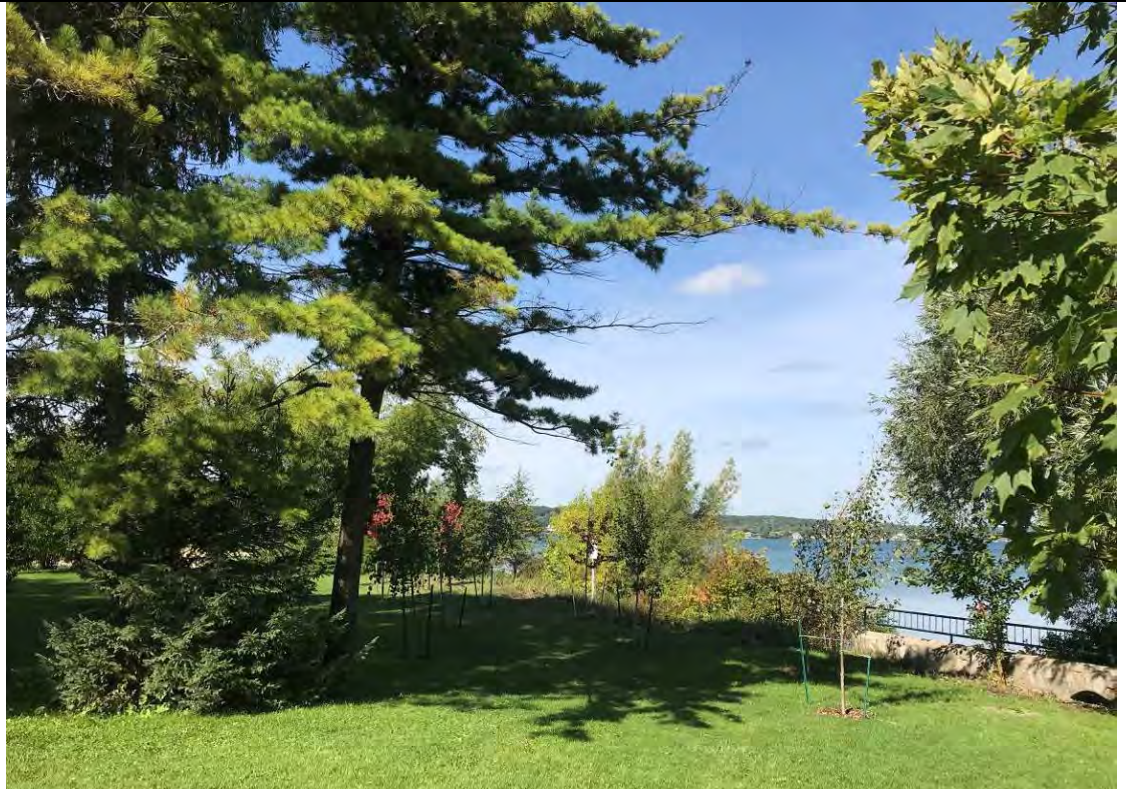
Photo No.**25****Date:**

Blending with Existing Trees

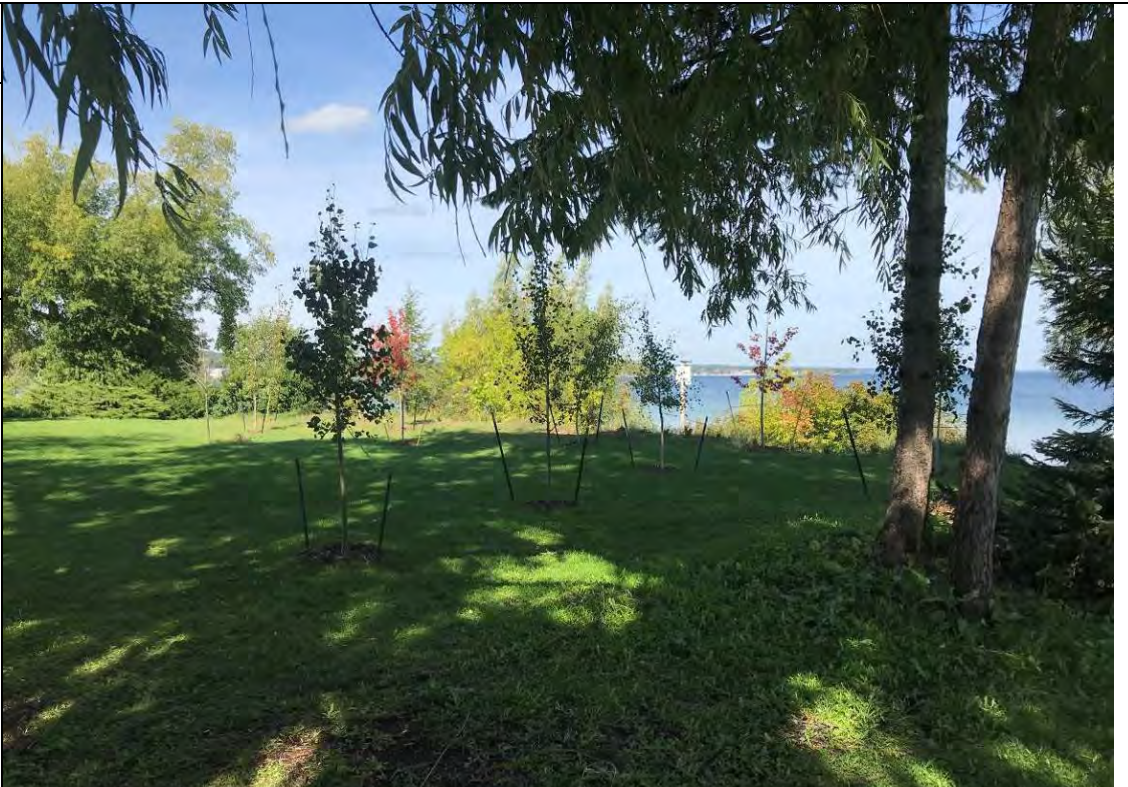
**Photo No.****26****Date:**

Blending with Existing Trees
