**GRAND TRAVERSE COUNTY  
BROWNFIELD REDEVELOPMENT AUTHORITY**

# **ACT 381 COMBINED BROWNFIELD PLAN**

Graetz Redevelopment Project  
647 East Eighth Street, Traverse City, Michigan

**REVISION DATE** October 31, 2013

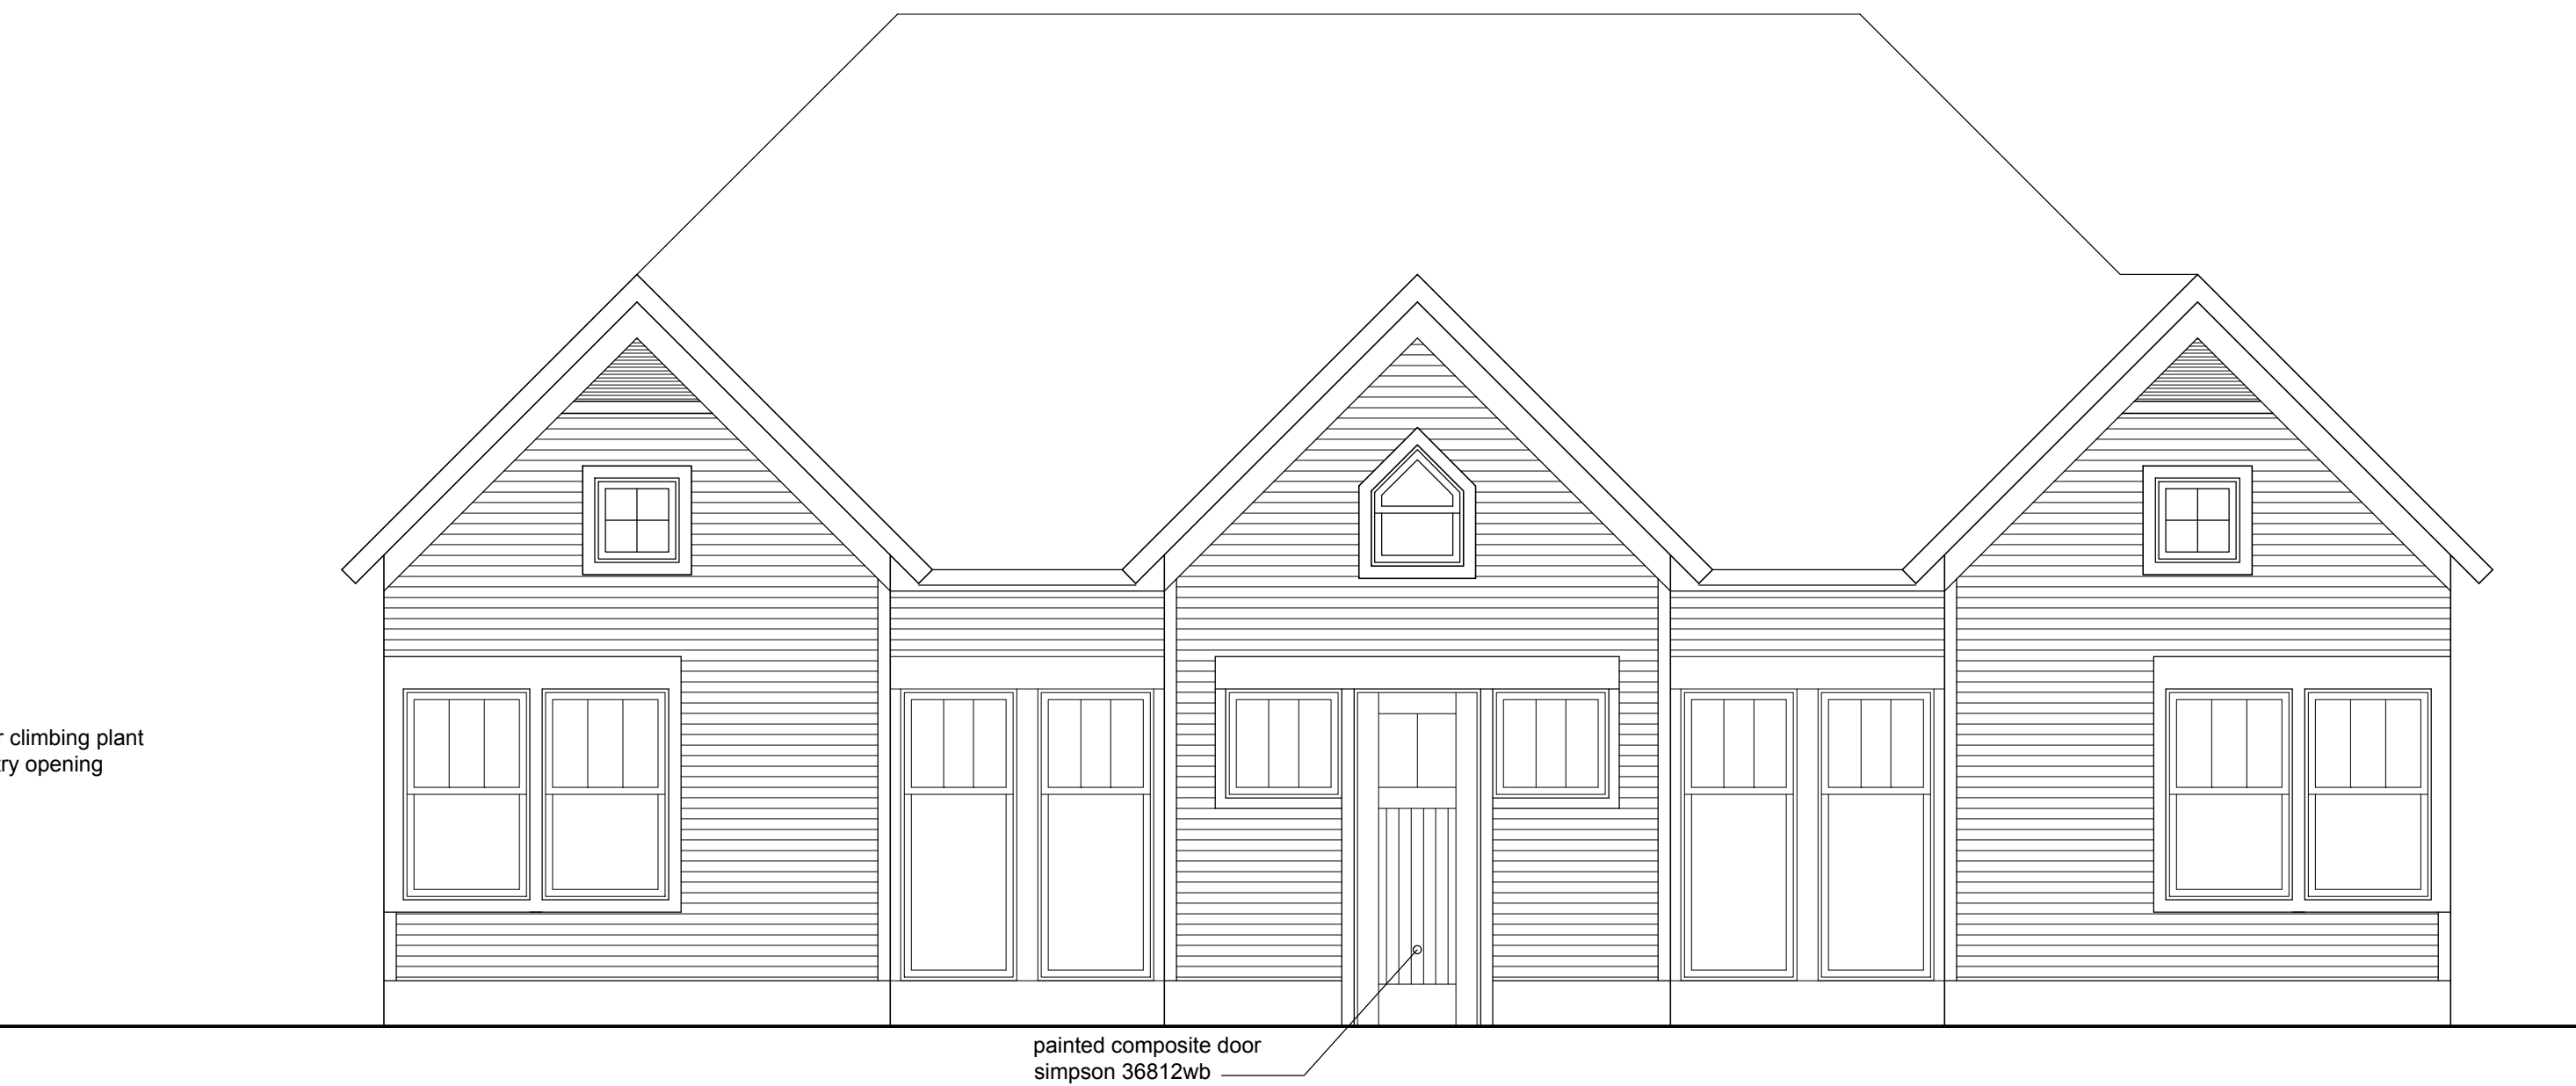
south elevation (8th street)  
SCALE: 1/4" = 1'-0"  
30% window

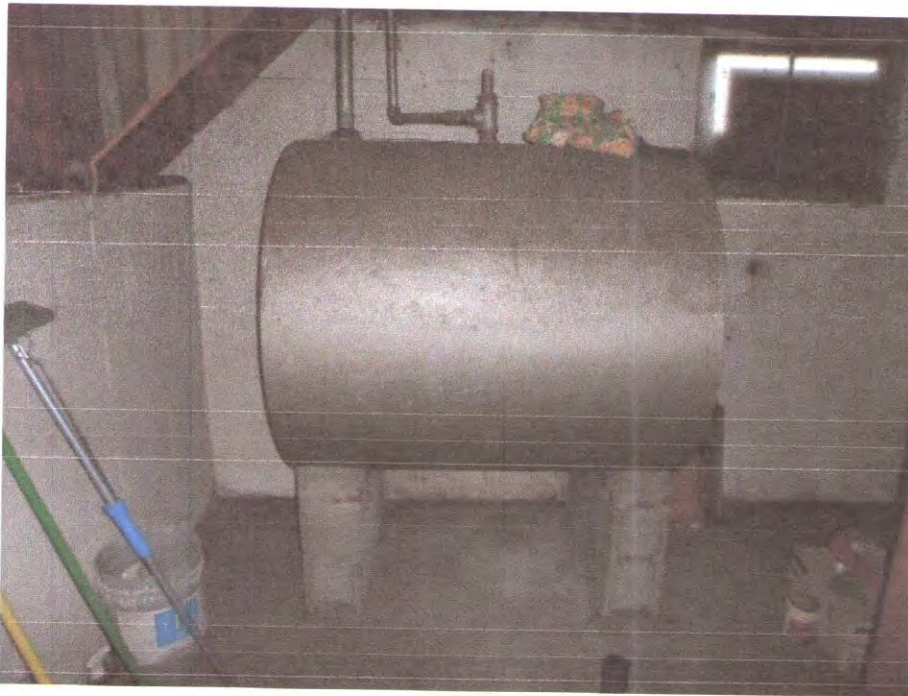
1. Photograph depicting the fuel oil AST located in the basement of the residence.

It should be noted that during the completion of the RSRA the potential for the residential structure to have been heated with fuel oil was identified. Interviews with the potential purchaser and real-estate agent confirmed the presence of an above ground storage tank (AST) was located in the basement of the residence along the east wall.

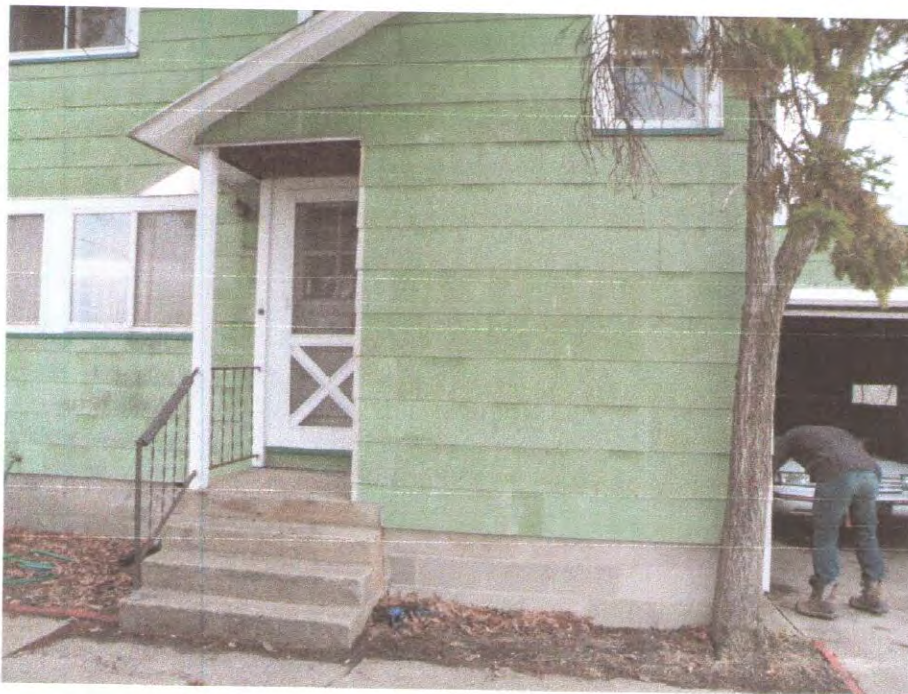
2. Photograph depicting the exterior of the residence in the vicinity of the fuel oil AST.
